Rapid Lesson Sharing

Event Type: Felling Tree Strike

Date: September 12, 2023

Location: Lookout Fire
Willamette National Forest
Oregon

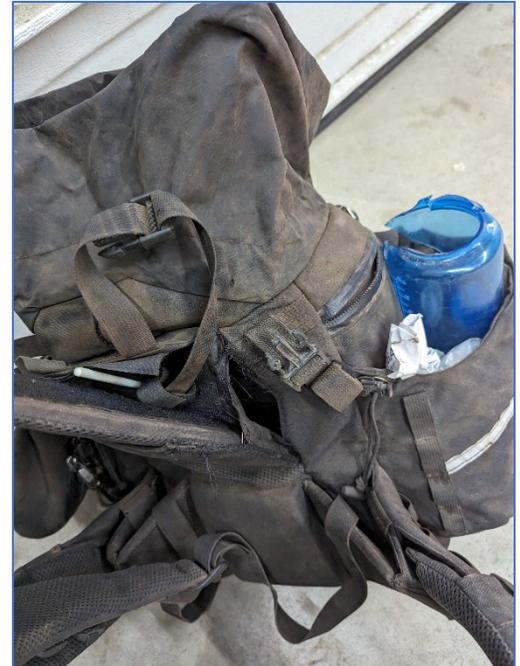
The swamper's line gear that took the direct hit—on the swamper's back—from the 30-foot tall falling snag. Notice how the line gear's hard plastic yoke was blown apart and the hard plastic water bottle was shattered.

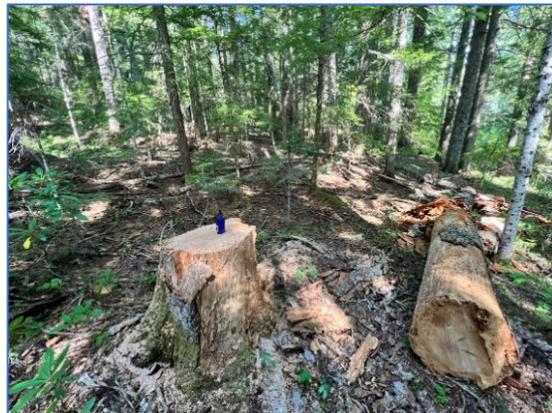
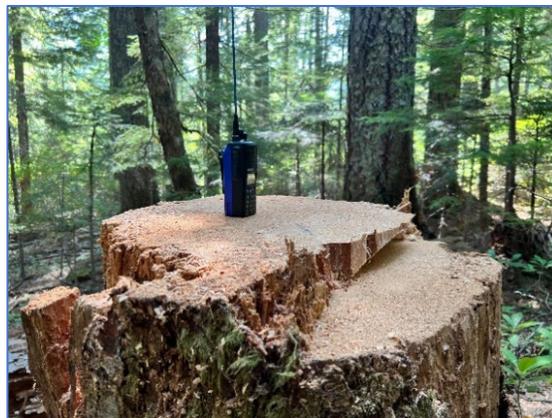
When it came time to execute the sloping cut, an error occurred. The sawyer inadvertently mismatched the two cuts that form the undercut by only using the kerf that was visible to align their cuts. This error left a nearly 3-inch bypass on the tree's offside that was obscured from sight. This bypass would ultimately change the direction of the tree's lay and disrupt the orientation of the back cut.

The hazard tree and its stump.

- ❖ During a felling operation, it is commonly believed that a sawyer can minimize risk by quickly making the necessary cuts to bring down a snag. However, instead of rushing the saw operation, it is better to slow down and methodically execute the cuts. It is advisable to ask for assistance or even consider turning down an assignment if necessary. By taking these precautions, the risk of accidents can be significantly reduced.

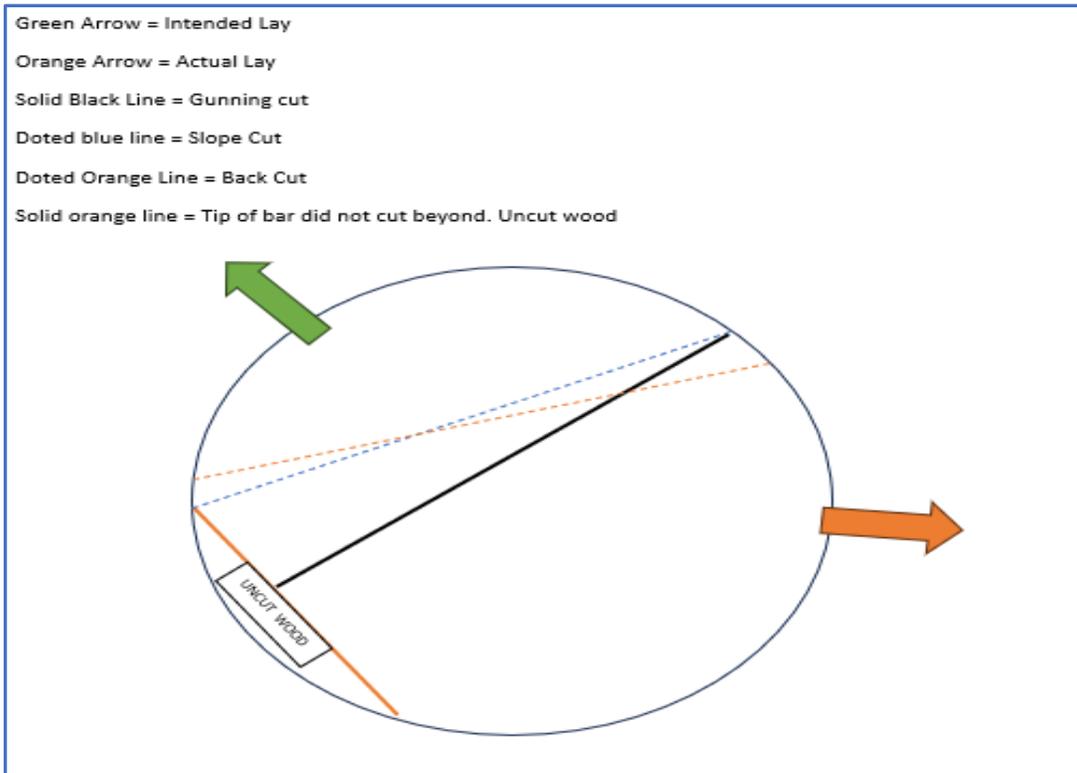
During the cutting process, the back cut was initiated and a single wedge was placed early to prevent the guide bar from being pinched if the kerf closed. However, due to misaligned cuts, the hinge on the tree stump was almost completely severed as the back cut advanced.

Illustration of the stump created by the crew boss.
