Event Type: Chainsaw Kickback Injury

Date: October 31, 2023

Location: McCoy Road Hazard Tree Abatement Project,
Detroit Ranger District, Willamette
National Forest, Oregon

The Story and Lessons from this Chainsaw Kickback Incident

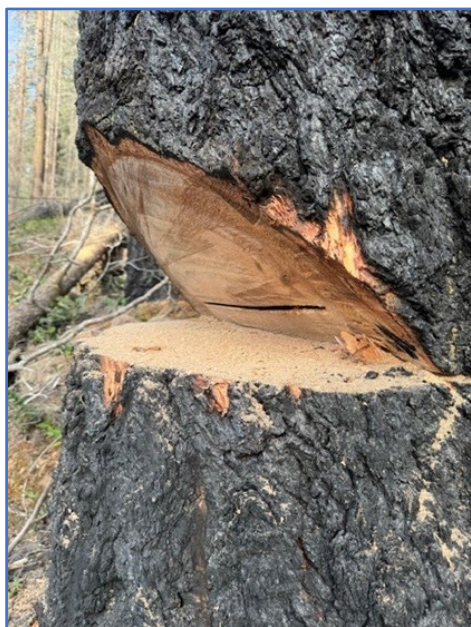
Front of tree.

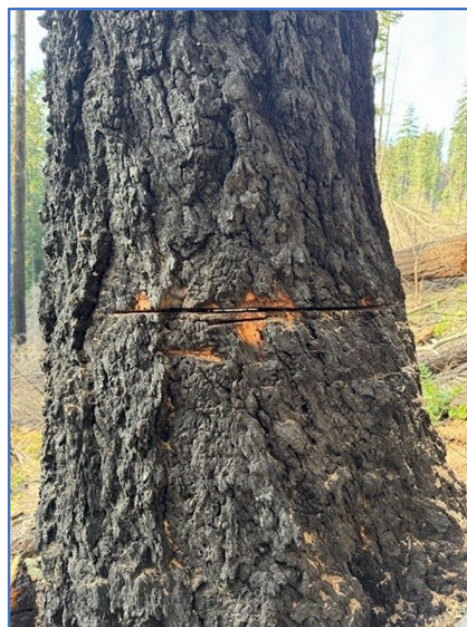
Back of tree.

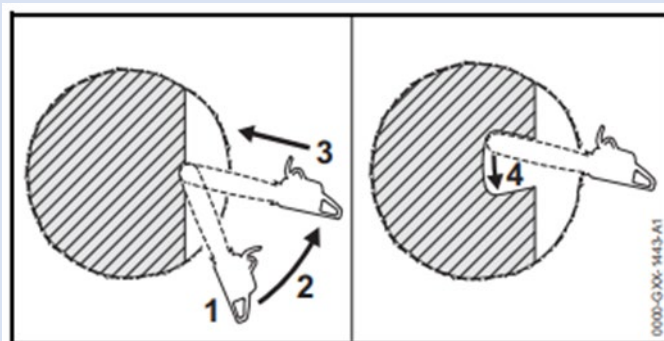
The plunge-cut method is typically used to allow the sawyer to remove wood from the center of the tree that would otherwise be inaccessible to the guide bar during the back cut. It involves performing a plunge cut from the front of the tree after creating a large undercut.

“It is crucial to note that this method is highly dangerous due to the use of the nose of the guide bar, which can result in a kickback. If you are inexperienced with a chainsaw, it is strongly advised not to attempt plunge-cutting.”

The plunge-cut method.

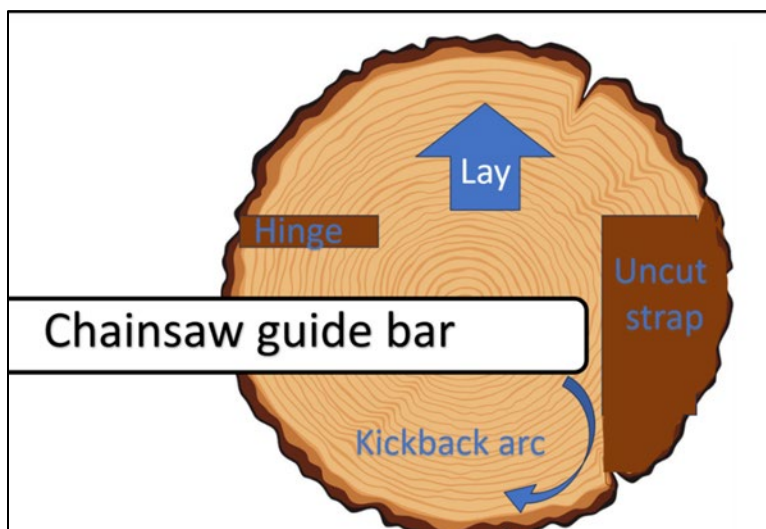
In this incident, the sawyer initiated a horizontal plunge-cut starting from the back and center of the tree. This cut extended all the way through the hinge and out the undercut. As a result, a portion of the hinge located in the center of the tree was removed, leaving two uncut sections of the hinge on either side. Each side had a large strap of wood behind the hinge that extended along the bole of the tree on both sides.

The intention was to subsequently cut up each of these straps separately, ensuring that they reached the desired thickness for the hinge. Once this thickness was achieved, the tree would be felled as planned.

Cross-section of the cut plan that the sawyer used.

During the back cut as the hinge wood was being set on one side, an unfortunate incident had just occurred. The sawyer accidentally caused the chainsaw guide bar to make contact with the strap wood, resulting in a kickback that was forceful enough to cause the guide bar to exit the back cut kerf and strike the sawyer on their upper right arm.

- ❖ When formulating a cut plan, it is important to consider the specific characteristics associated with each saw operation. By taking these characteristics into account, you can develop a cut plan that aims to minimize complexities while achieving the desired result. It is crucial to remember that every situation is unique and necessitates a comprehensive procedural size-up.

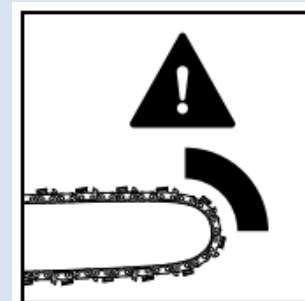
Kickback can occur when the moving chain near the upper quadrant of the bar nose comes into contact with a solid object or gets pinched. When the kickback reaction is stronger, it becomes more challenging for the operator to maintain control of the chainsaw.

There are various factors that can influence the occurrence and force of the kickback reaction. These factors include the speed of the chain, the speed at which the bar and chain make contact with the object, the location and angle of contact, the condition of the chain, and whether the chain is slowed or stopped by other factors (kickback danger zone).

- Never use a saw if the chain brake does not function properly.
- Always maintain a firm grip with two hands and your thumb wrapped securely around the front handlebar.
- Start any borecut with the bottom or attack portion of the bar.
- Avoid contacting any object with the upper quadrant of the bar nose.
- Maintain full throttle.
- Use a sharp, well-maintained chain.

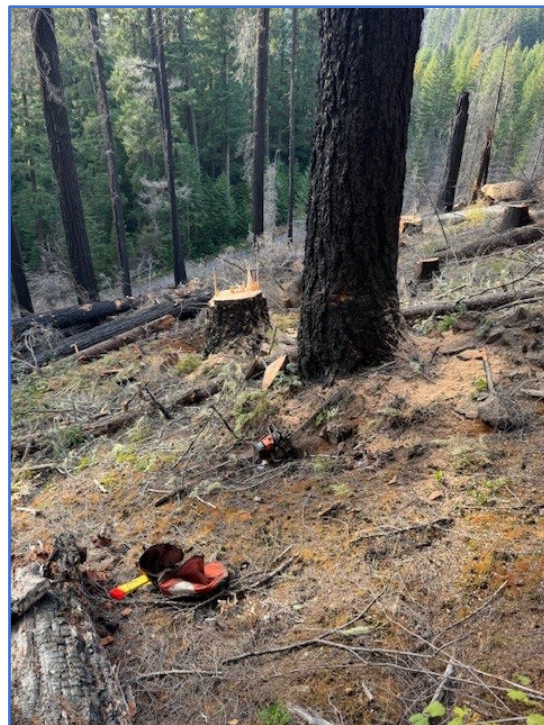
Reacting promptly, the sawyer immediately dropped the chainsaw and began to assess the condition of their arm. As the back cut operation was left unfinished, the fir tree remained upright due to the secure hold provided by the uncut strap wood.

The standing 36-inch diameter Douglas fir tree in the foreground is the tree in which the kickback occurred and injured the sawyer. Note the U.S. Forest Service road at the base of the hill.
