GRAY WOLF TRAIL CREW NOTES

11/03/23

Location: Lower Dungeness, ONF

Objective – repair a puncheon that had failed due to 3 sills losing their supporting dirt.

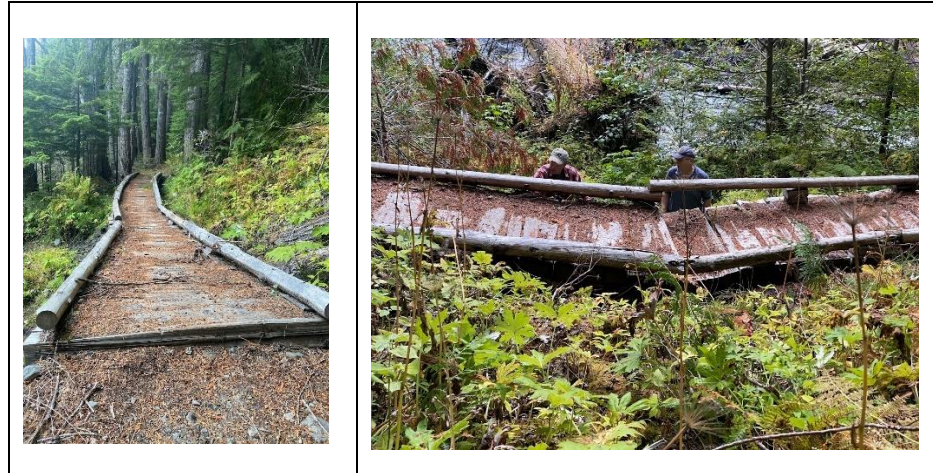
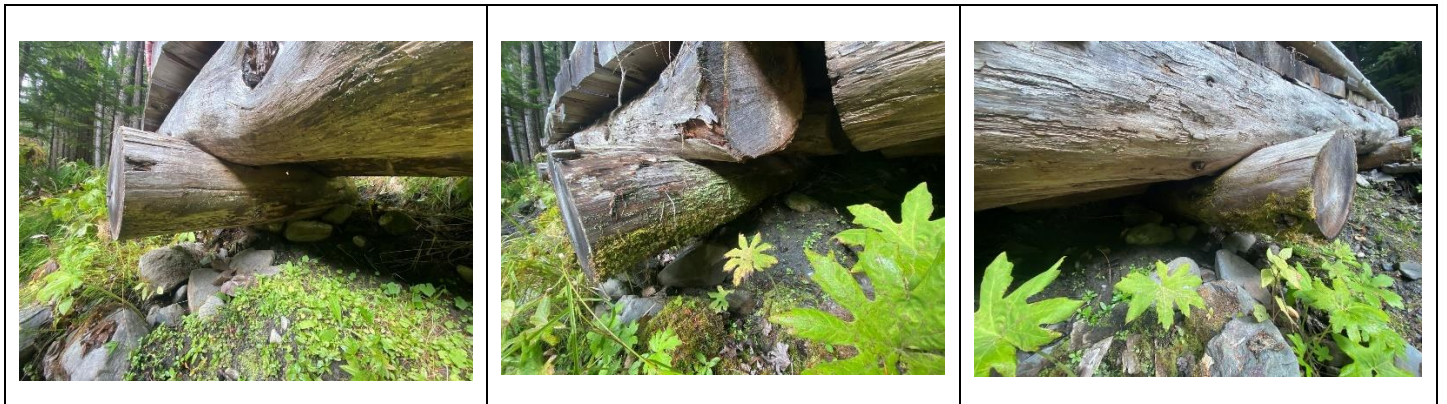
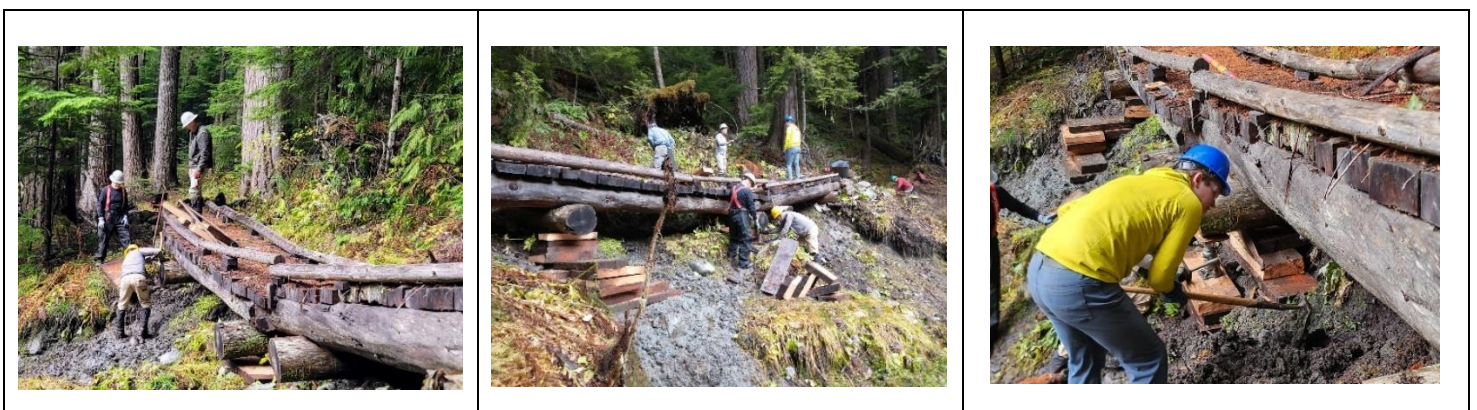
You can see here that 3 of the sills were on dirt on their uphill side, but floating in the air on the downhill (river) side. Martin, Jim and Rebecca went in a few weeks ago to do a survey of it and come up with a plan for a repair. Mike had analyzed it even before that. So a lot of thought went into this project.

1. Jack up and put in supports for the 3 sills.
2. Address drainage to control the water that caused the problem in the first place.
3. Build a rock wall to buttress one end of the puncheon.

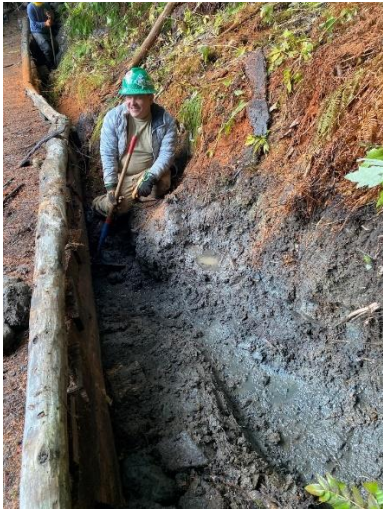
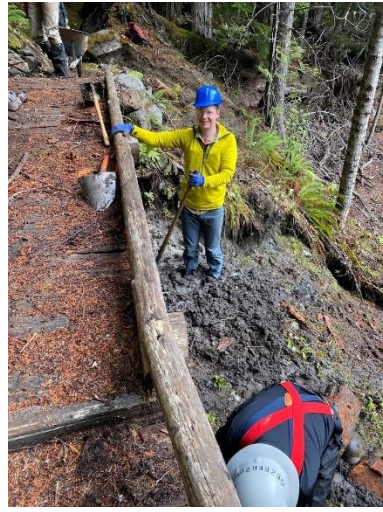
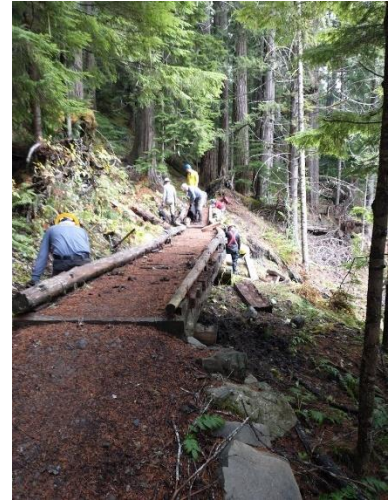
Shoveling in the muck; sawing old planks; clearing out the uphill ditch; using jacks to push up the puncheon and hold it in place – there were a lot of different jobs happening all at once.

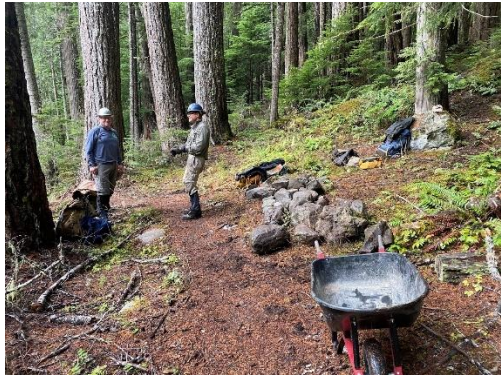
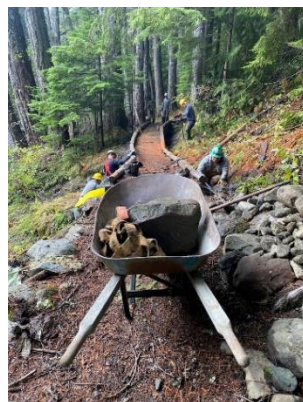
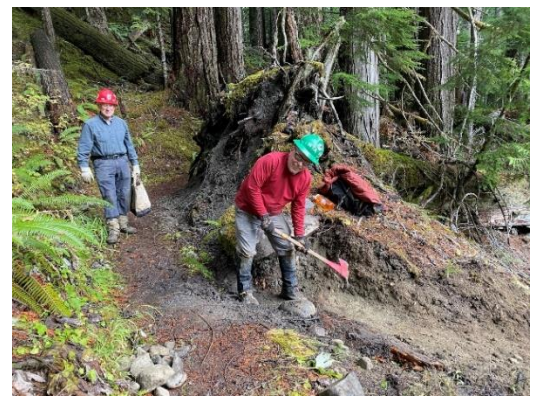
Rocks had to be collected. Off-site drainage work needed to be done.

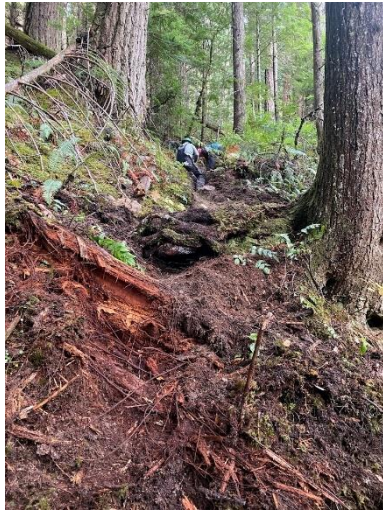
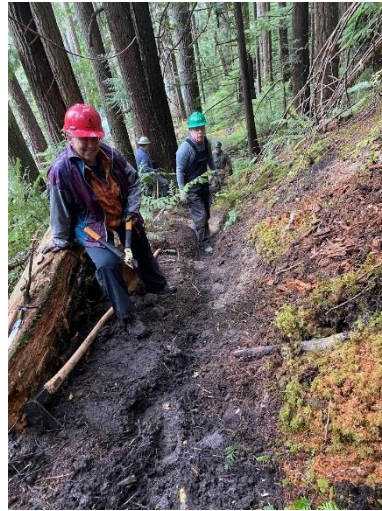
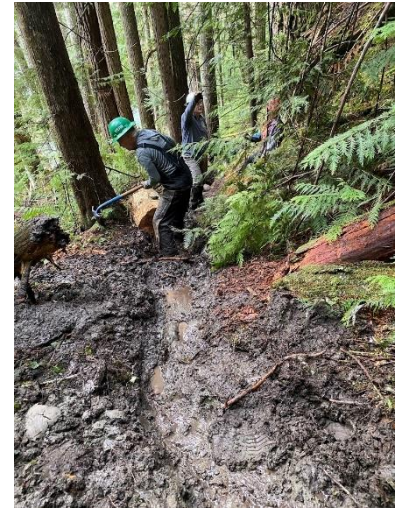
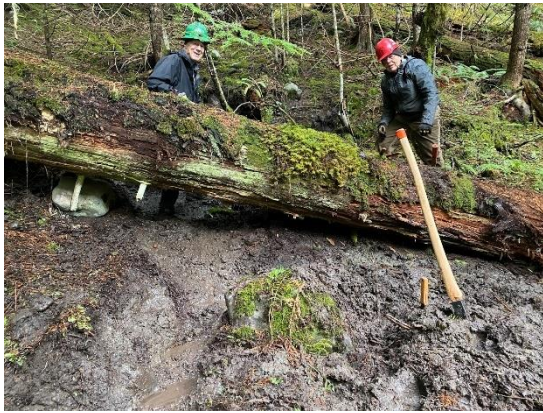
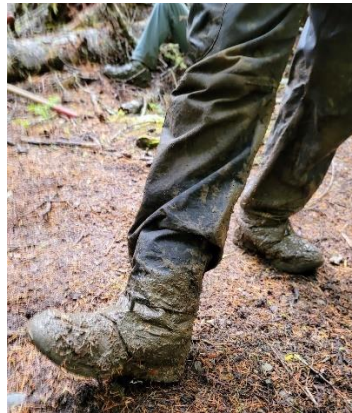
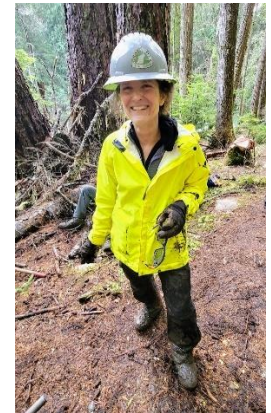
Meanwhile, a team of us were dealing with the drainage on the hillside above the puncheon. So that makes three focuses on drainage: the ditch alongside the puncheon, the drain from the rootball above the puncheon to and underneath the structure, and our job which was to catch the mother lode of the problem and get it to drip into the hillside to the side of the site. We had to explore around for a while in the beginning, trying to find the source of the problem (besides the obvious fact that we live in the Pacific Northwest). Then we had to dig a long ditch, under large roots, through the muck, channeling the water to where it will get absorbed by the hillside and won't damage the puncheon or the trail. At several points we each had our feet buried in mud so deep it took strength to extract ourselves.

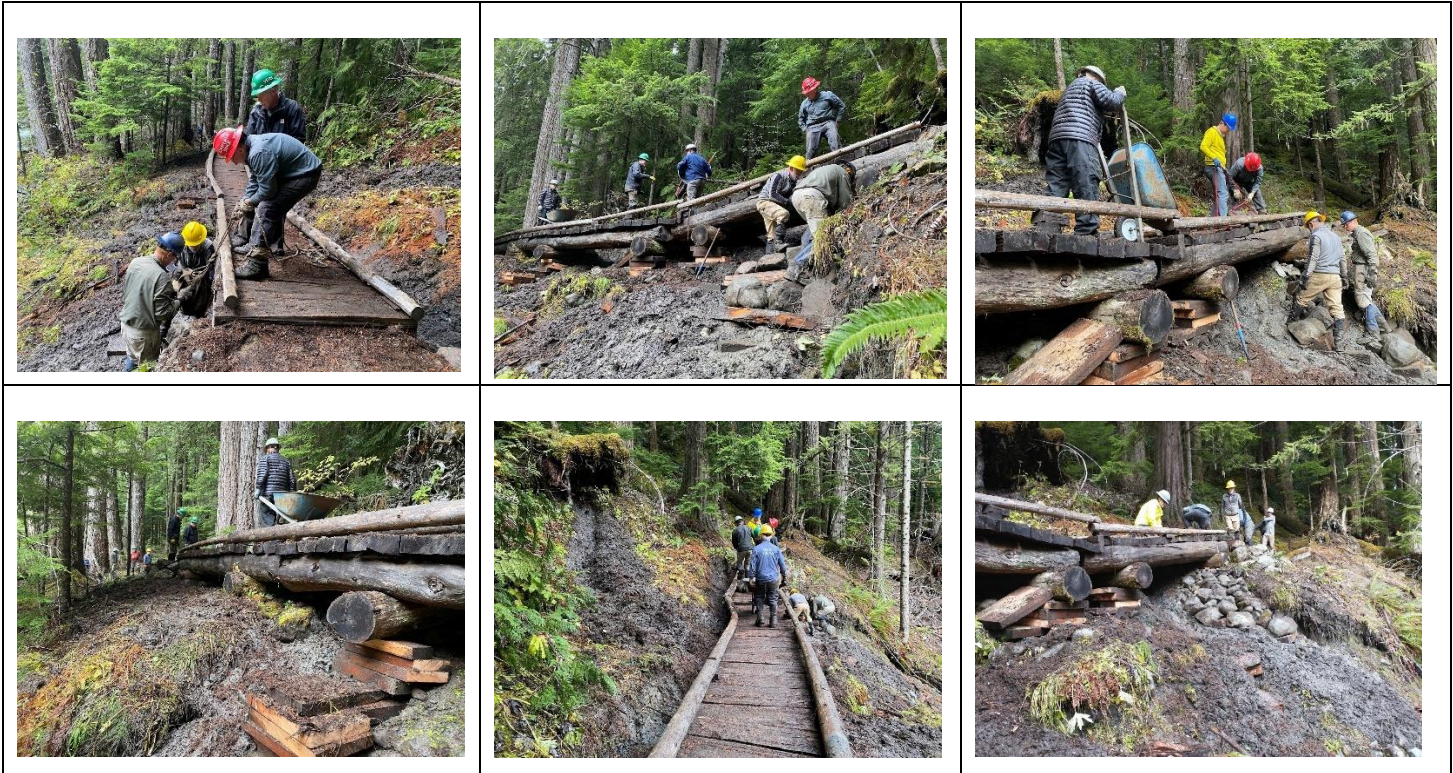
After the puncheon repair was done, then the rock wall could be built on the downstream end to buttress up the northernmost sill. Meanwhile, we were also scraping the puncheon clean. If we get the organic material off, it increases the lifespan of the wood as well as reducing the slick footing problems.
